# Upgrading for better performance and hygiene

Customer case - April 2020

## Rendering of chicken by-products

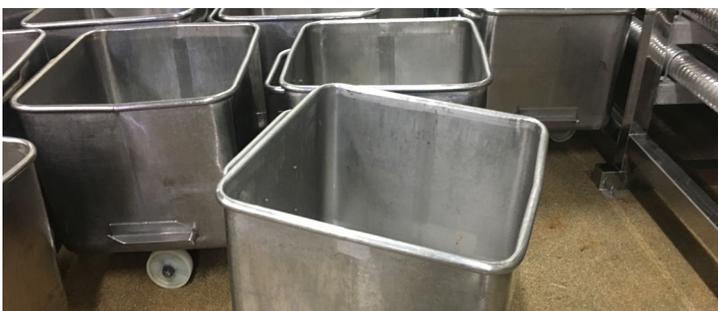
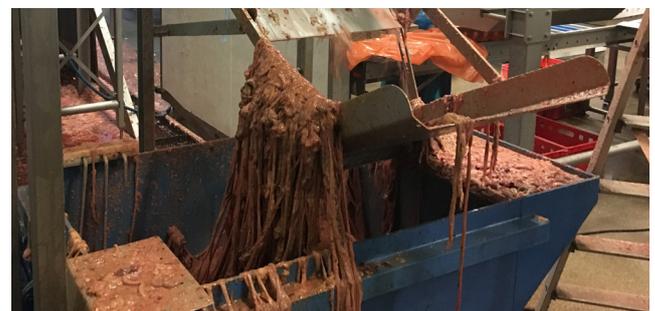
Back in January 2019, the Plukon Food Group used a progressive cavity pump which was under-performing. As a temporary solution for loss of performance, the Plukon Food Group had to transport the by-products in transportation bins (as shown above), emptying them on conveyor belts for further transport to the production facility.

Manual handling of a volume of approx. 3,7-4,3 t/h was demanding, and it was therefore time to switch to a more contemporary solution in view

The use of safety hatches failed to rectify matters. This led to the by-products being handled inappropriately, resulting in unsatisfactory working conditions, poor hygiene and more cleaning.

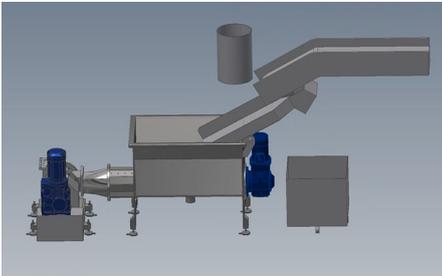
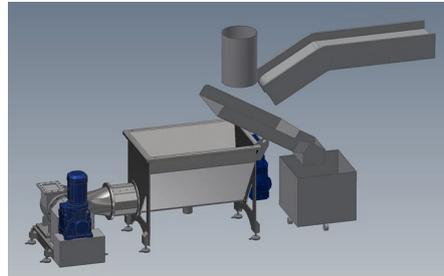
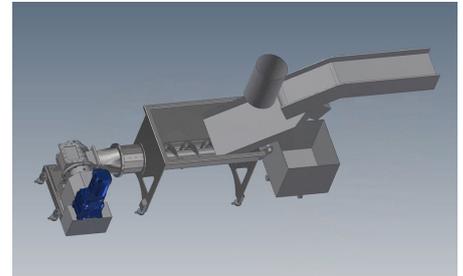
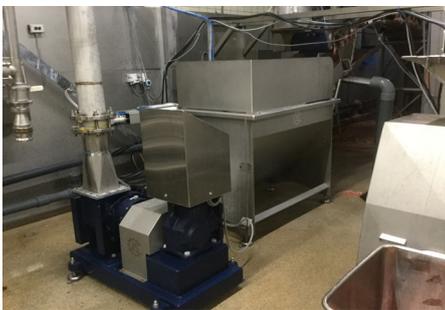
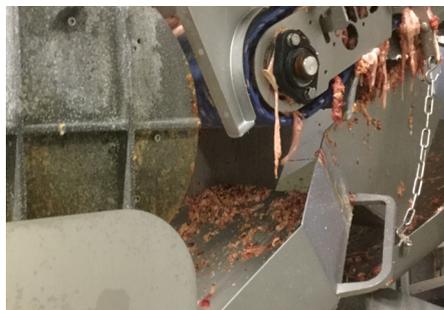
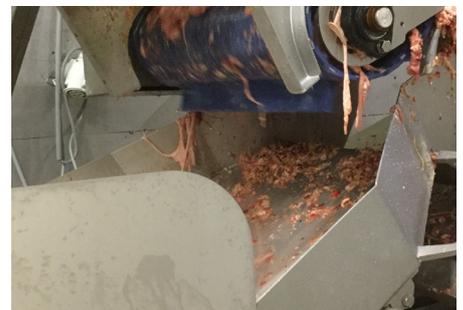
## THE SOLUTION - FOCUSING ON PERFORMANCE AND BETTER HYGIENE

The new solution consists of:

- JS Infeed Hopper
- JS Lamella pump
- A security hatch on top of the hopper
- Ø 110 mm spigot at the bottom of the hopper
